**U.S. Naval Supply Research & Development Facility
Bayonne, New Jersey**

21 February 1952

INTERIM REPORT ON THE INSTALLATION
OF
CARBON MONOXIDE ELIMINATOR MUFFLERS

ENGINEERING REPORT NO. 5.2120
Project Group No. NT-003-020(b)

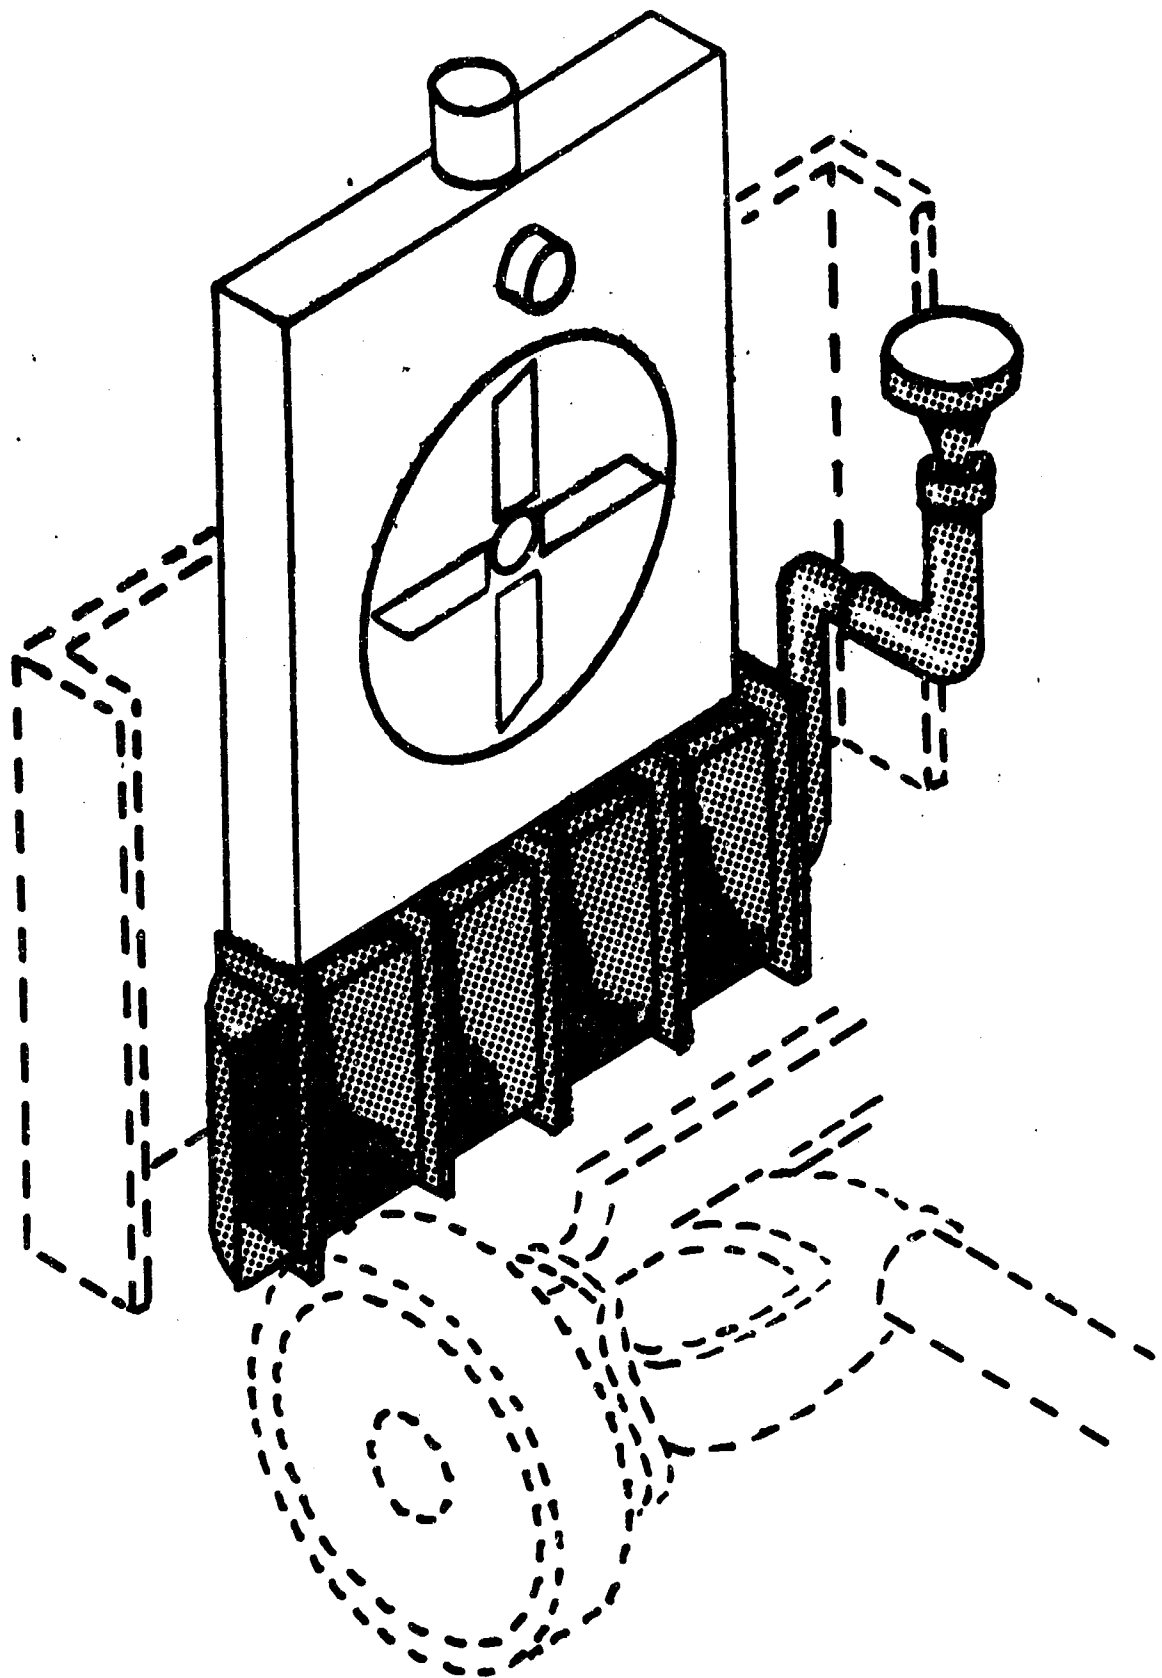
FIG. 10

The Safety Department at Norfolk has commented on the installation of this muffler. They have recommended that the direction of the exhaust outlet be changed so that exhaust gas and the occasional sparks coming out of the muffler opening would be directed toward the floor rather than forward along the side of the engine.

POSITION OF MUFFLER AS INSTALLED ON 6000 LB. FORK TRUCK.
